Replacement state of Lifting loop with threaded end

Criteria for replacement state of Lifting loop with threaded end

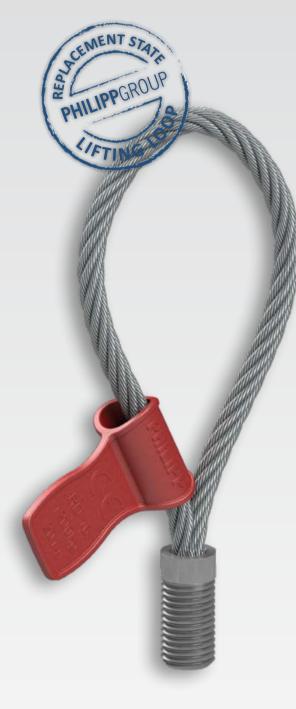
Loosening of external layer

To be replaced

- ⊘ Broken strand (Picture)
- \odot Kinks and bends
- ⊘ Loosening of external layer (Picture)
- ⊘ Contusion in free lengths
- ⊘ Contusion in the support area of the eye with more than 4 broken wires (Picture)
- \odot 4 broken wires on a length of the threefold of the wire rope diameter
- \odot 6 broken wires on a length of the sixfold of the wire rope diameter
- \odot 16 broken wires on a length of the thirtyfold of the wire rope diameter
- \odot Corrosion pits
- ⊘ Damages, deformation or strong wear and tear of the wire connection

If **one of the above-mentioned points** is fulfilled the Lifting loop with threaded end has reached its replacement state and **must not be used anymore**.

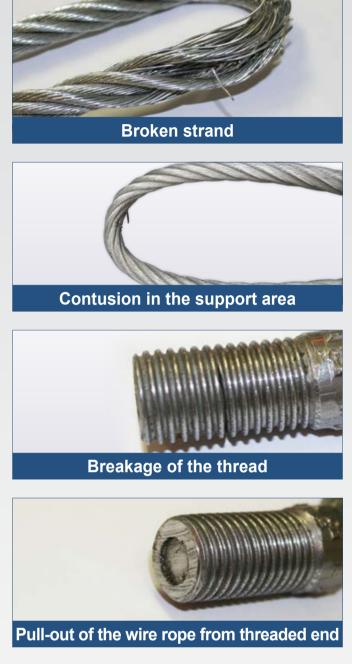
Test dime	ensions	
Load class	d _{M.min} [mm]	
12	11,50	
14	13,50	
16	15,45	
18	17,40	
20	19,40	
24	23,40	
30	29,40

36	35,40	d _{M.min}
42	41,20	
52	51,20

(threaded component) (Picture)
\odot Breakage of the wire connection end (threaded part) (Picture)
⊘ Deformed thread (Picture)
\odot Welding or other strong heat influences
\odot Pull-out of the wire rope from threaded end (Picture)
⊘ Unreadable or missing tag
